FATIGUE IN CERAMICS WITH INTERCONNECTING WEAK INTERFACES: A STUDY USING CYCLIC HERTZIAN CONTACTS

Abstract—The deformation and fatigue of ceramics containing a contiguous network of weak interfaces is described. Observations of damage evolution within subsurface Hertzian compression fields in silicon carbide, alumina, and a glass–ceramic with dense, weakly bound platelet structures provide an experimental basis for the description. In a contact load–unload cycle, shear faults at the platelet interfaces undergo forward and reverse sliding. In cyclic loading, individual faults show evidence of frictional degradation, and the macroscopic damage zone undergoes progressive expansion. A sliding shear fault model with load–unload–reload hysteresis is developed to explain the results. Central to the model is the incorporation of resistive sliding tractions at the sliding interfaces, with allowance for progressive frictional attrition. A case study using fatigue data from the silicon carbide serves to illustrate the viability of the model.

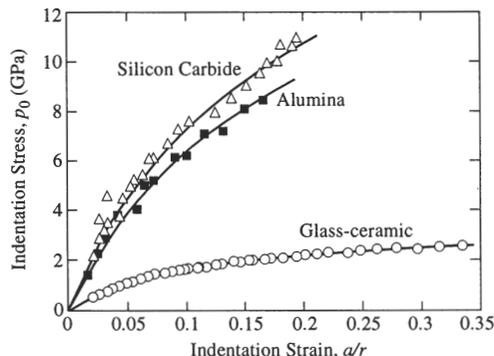
Fig. 1. Indentation stress–strain curves for *in situ* processed silicon carbide composite, alumina–calcium hexaluminate composite, and mica-containing glass–ceramic. Data obtained using tungsten carbide spheres of radius $r = 1.98$ – 12.70 mm. Solid curves are empirical fits through the data. Note significant deviation from linear Hertzian elastic response. (Alumina data courtesy of L. An and H. M. Chan, silicon carbide and glass–ceramic data from Ref. [23].)

Plots of indentation stress-strain curves for the three test materials are shown in Fig. 1. Significant nonlinearities are indeed observed in all three cases, indicating the activity of dissipative deformation processes [27, 28].

Another issue is that of stochastics. In our computations of Section 4 we chose parameters corresponding to most favourable conditions for sliding. In reality, these parameters must vary spatially within the subsurface zone, because of inherent inhomogeneity in the Hertzian field [34] and variability in interface orientation relative to the principal stress trajectories [29]. We should therefore expect individual sliding events to initiate sequentially rather than simultaneously during any load-unload cycle, so that the cumulative manifestation of a population of discrete elements with straight-segment hysteresis loops (Figs 7 and 8) is a smoothed-out indentation stress-strain curve (Fig. 1).

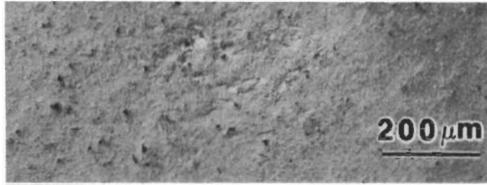
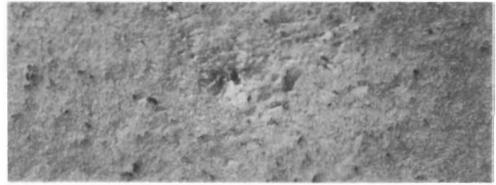
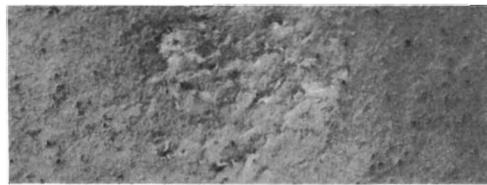
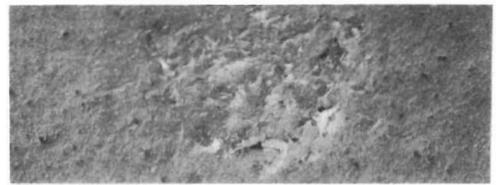
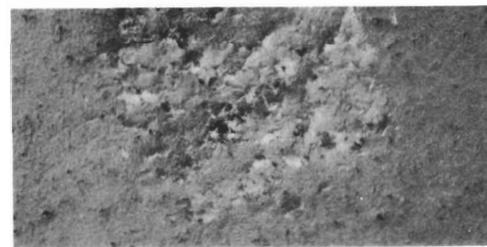
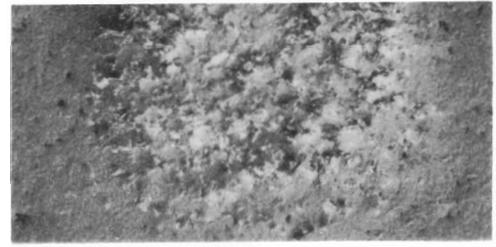
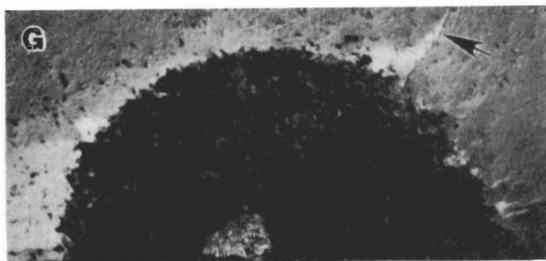
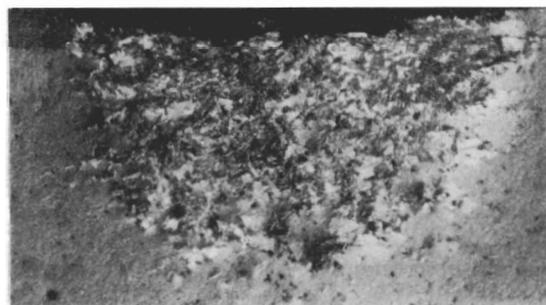
Fig. 2. On facing page. Optical micrographs in Nomarski illumination showing half-surface (top) and section (bottom) views of Hertzian contact sites in silicon carbide composite: number of cycles (A) $n = 1$; (B) $n = 10^1$; (C) $n = 10^2$; (D) $n = 10^3$; (E) $n = 10^4$; (F) $n = 10^5$; (G) $n = 10^6$. Peak contact stress $p_0^* = 6.0$ GPa, using WC sphere of radius $r = 3.18$ mm at load $P = 1000$ N and frequency 10 Hz. Note appearance of radial crack (arrow) from surface contact zone in (G). (After Ref. [24].)

Figure 2(A)-(G) illustrates fatigue damage patterns in the silicon carbide composite, for $n = 1$ to 10^6 cycles at a peak contact stress $p_0^* = 6.0$ GPa [24]. In this sequence the half-surface (upper) and section (lower) views are obtained using "bonded-interface" specimens [18, 19], prepared as follows: (i) two polished rectangular half-blocks are glued together at their side faces with thin adhesive; (ii) indentations are made on the polished top surface symmetrically across the trace of the bonded interface; (iii) the adhesive is dissolved in solvent and the half-blocks separated; (iv) the contact regions are viewed in Nomarski illumination. The density and size of the damage zone show a dramatic increase with number of cycles, from modest damage at $n = 1$ to near-crater formation, with attendant radial cracks, at $n = 10^6$. Also notable in the section views is the onset of damage at some distance *below* the contact area, corresponding to the region of maximum shear stress [17]. In these tests, acoustic activity during the first loading half-cycle begins above $p_0 \sim 3$ GPa and increases strongly up to the peak $p_0^* = 6.0$ GPa, indicating a proliferation of microdeformation events beyond some incubation pressure; lesser, but not insignificant, activity also occurs below $p_0 \sim 2$ GPa during the first and each subsequent unloading half-cycle, indicating some reversal in the deformation process [24].

approaches N on the logarithmic scale of Fig. 9 is consistent with the rate of damage accumulation observed in the micrograph sequence of Fig. 2.

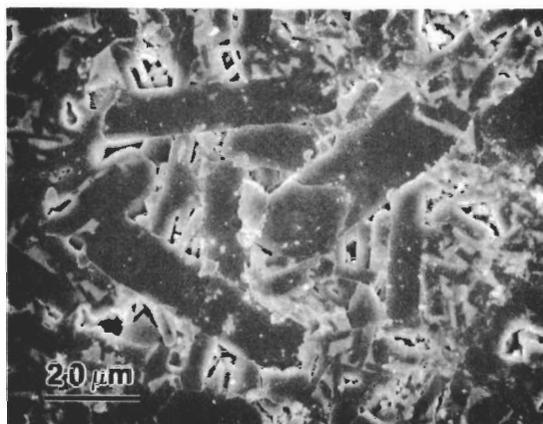
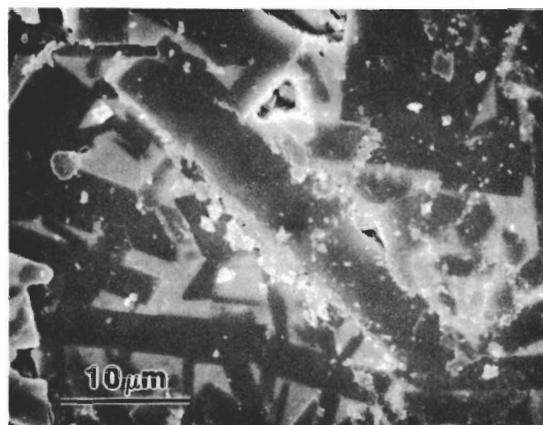
Fig. 3. Scanning electron micrographs of Hertzian contact damage in silicon carbide composite after 10^6 cycles, taken from center regions of subsurface damage zones in Fig. 2(G). Note surface cavities from material removal and sliding-interface debris.

Figure 3 shows higher magnification views of the damage in the silicon carbide after $n = 10^6$ cycles, from the near-center region of the subsurface zone in the section of Fig. 2(G). There is clear evidence of failure at some of the SiC-YAG interfaces. Material has been dislodged from the surface, and copious subgrain-scale debris is visible. The indications of interfacial frictional degradation by forward-reverse sliding is compelling. In this context, recall from Section 1 the previously reported observations of

the friction process at all in this study. The importance of friction in cyclic contact fatigue is evident from the presence of surface debris, most notably in Fig. 3. This kind of persistently adhering debris product is symptomatic of severe wear at highly stressed sliding facets [6, 39]. The roles of interface roughness, surface chemistry, electrostatic interactions, and other variables in these wear processes hold remain to be determined.

There is the further question as to why the damage zone expands in size as well as in density during cyclic fatigue sequences such as that in Fig. 3. As frictional degradation occurs at the sliding fault interfaces within the initial damage zone so does the rigidity of the damage zone diminish, transferring more of the contact load to the surrounding material. The faults in this adjacent region are themselves now susceptible to sliding, so the damage zone spreads. In fixed-load cycling, the contact area itself expands as the material continues to "soften", reinforcing the effect.

enhanced capacity for absorbing impact energy by damage accumulation. The material is also rendered potentially machinable [42]. Conversely, the material becomes susceptible to fatigue and wear [24] (Fig. 3). The nature of the bonding between the platelets (needles) and any second phase in the microstructure becomes a critical issue. Internal tensile mismatch stresses may enhance fatigue degradation by opening up the sliding interfaces, although the effect will be insignificant if $\mu\sigma_R \ll \tau_C$ in equations 4 and 5 (cf. $\mu\sigma_R = 0.1$ GPa, $\tau_C = 1.2$ GPa, for our silicon carbide ceramic in Section 4). Note that grain size does not enter into the model of Section 3, so there is an implied absence of any microstructural scaling effect in the sliding micromechanics. The same is certainly not true of materials in which the growth of extensile cracks from the shear faults is an important component of the damage process, where grain size is acknowledged as a critical factor in the crack initiation [29].

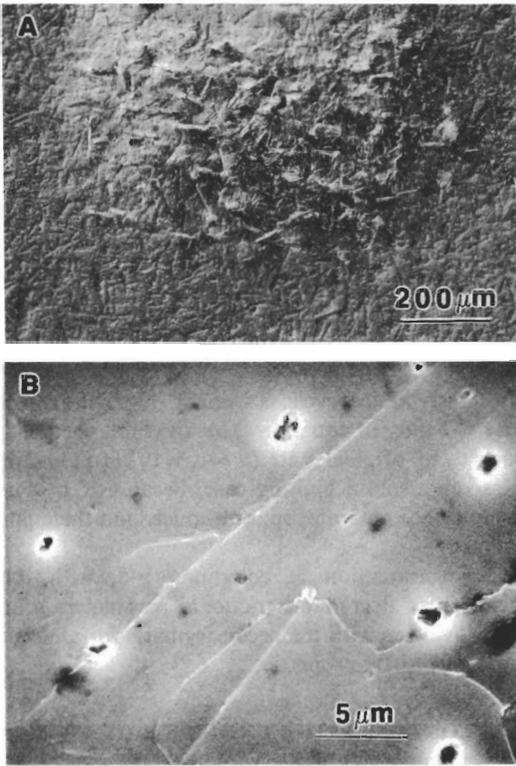
Fig. 4. (A) Optical and (B) scanning electron microscope views of contact damage in alumina-calcium hexaluminate composite $n = 10^5$ cycles. Peak contact stress $p_0^* = 5.6$ GPa, using WC sphere of radius $r = 3.18$ mm at load $P = 1000$ N and frequency 10 Hz. (Courtesy of L. An and H. M. Chan.)

Comparative micrographs for the alumina composite, Fig. 4, and the glass-ceramic, Fig. 5, after $n = 10^5$ cycles reveal analogous sliding-interface damage mechanisms.

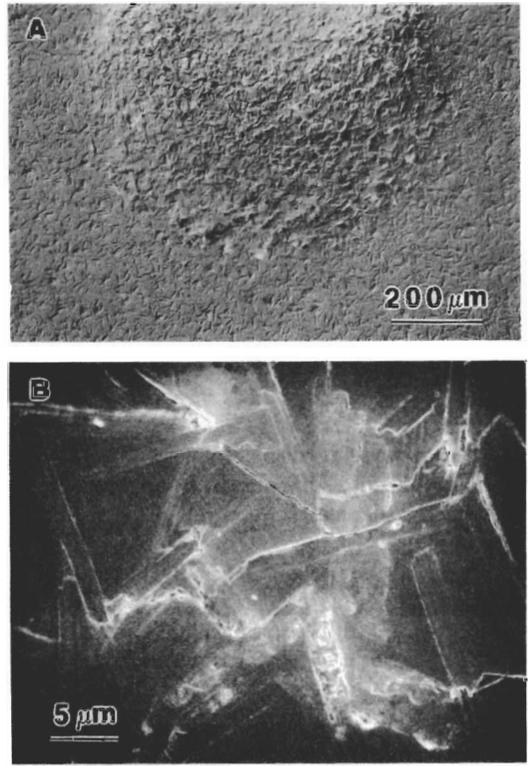
Fig. 5. (A) Optical and (B) scanning electron microscope views of contact damage in mica-containing glass ceramic after $n = 10^5$ cycles. Peak contact stress $p_0^* = 1.63$ GPa, using WC sphere of radius $r = 3.18$ mm at load $P = 500$ N and frequency 10 Hz. (Courtesy of H. Cai.)

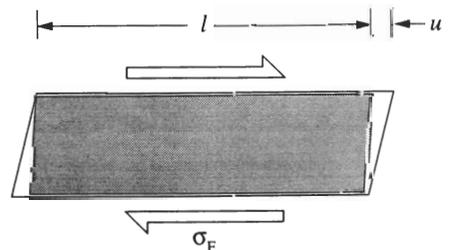
Fig. 6. Closed shear fault at sliding intergrain boundary of length l , at shear stress σ_F and displacement u . Shear stress at interface drives sliding, compression stress maintains closure.

The closed-fault system of Fig. 6 slides under the driving action of resolved shear stresses in the subsurface Hertzian field. These shear stresses are determined as a differential in principal normal stresses σ_1 and σ_3 , with $\sigma_3 < \sigma_1$ everywhere and σ_1 and σ_3 both compressive (negative) in the subsurface contact zone [34]. Let us define dimensionless α coefficients, positive in this compression zone, by normalizing the stresses to the mean Hertzian contact pressure $p_0 = P/\pi a^2$

σ_R , at the interface. Following the lead of rock and soil mechanics [35], the *net* resolved shear stresses on the forward (+) and backward (−) sliding fault in Fig. 6 may be written [29]

Certain issues concerning the damage mechanics are not addressed by the present model. It is assumed in our analysis that the interfacial sliding in Fig. 6 occurs uniformly along the length of the facet. In reality, a shear crack must first initiate from some nucleation site and spread along this interface, in much the same way as fiber-matrix debonding occurs in reinforced composites. An attendant issue is the manner in which the shear strains caused by the interfacial sliding are accommodated by the structure. Some of this deformation could be relieved by block slip or twinning in the sheared grains. In the absence of any such relief mechanism, the strain must be accommodated by cracks or cavities, resulting in some dilatancy [35, 40]. There is some evidence of cavity formation at platelet interfaces in the present SEM views of Fig. 3, as well as in earlier subsurface studies of Vickers indentation damage in other materials (zinc sulphide) [41].

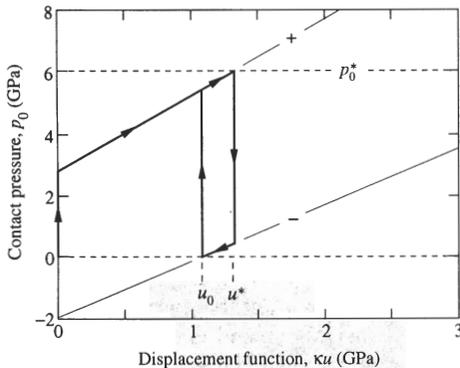
Fig. 7. Constitutive relation for shear fault displacement u as function of Hertzian contact pressure p_0 , for single load-unload-reload cycle in silicon carbide composite. Inclined light lines represent equilibrium relations for forward (+) and reverse (-) sliding. Solid segments represent cyclic path, showing unload-reload hysteresis between displacements u_0 and u^* .

These functions are plotted in Fig. 7 as the inclined upper (+) and lower (-) light lines for an initial loading-unloading-reloading cycle. (We show Fig. 7 with calibrated axes, but defer discussion of the calibration procedure to the next section and consider only qualitative features here.) The path traversed by the fault in $p_0(u)$ space is indicated by the heavy lines with arrows: inclined segments denote fault sliding branches; vertical segments denote stationary

branches. In the case shown, the peak load p_0^* is sufficiently high that reverse sliding occurs during unloading, i.e. $u^* > u_0$: u^* corresponds to the peak displacement along the upper (+) line, and is obtained at $p_0^+ = p_0^*$ in equations 2(a) and 3; u_0 corresponds to the remnant displacement at full unloading along the lower (-) line, and is obtained at $p_0^- = 0$ in equations 2(b) and 3

values $\mu(1) = 0.10$ and $\tau_c(1) = 1.2$ GPa to match as well as possible the onset of forward sliding at $p_0 > 3$ GPa during initial loading and reverse sliding at $p_0 < 2$ GPa during initial unloading, as indicated by the acoustic activity observations mentioned in Section 2.3 [24]. These are the parametric values actually used to plot Fig. 7, at a peak contact stress $p_0^* = 6.0$ GPa.

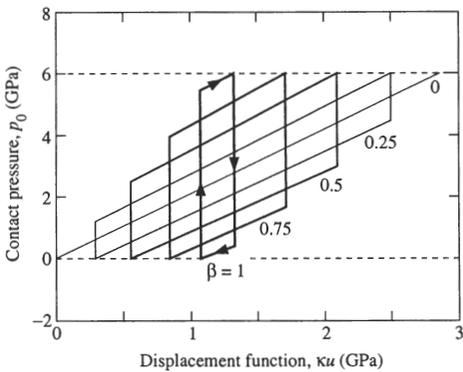
Fig. 8. Same as Fig. 7, but showing how unload-reload hysteresis loop widens and flattens as degradation coefficient β degrades with cycling.

Accordingly, in Fig. 8 we plot hysteretic unload-reload loops for several values of β for our silicon carbide composite. At the upper limiting value $\beta = 1$ ($n = 1$), the loop reproduces the zero degradation unload-reload configuration of Fig. 7. At the lower limiting value $\beta = 0$ ($n = N$), the loop condenses onto a straight line through the origin, corresponding to frictionless sliding, i.e. total degradation. As β diminishes (n increases) within these limits, i.e. as degradation proceeds, the hysteresis loop widens and flattens out. In this description, the widening differential between displacements u^* and u_0 (equation 5, cf. Fig. 7) provides a measure of microstructural "loosening" during cycling. These two displacements are plotted in Fig. 9 as a function of $\log n$, assuming $N = 2 \times 10^6$ for total degradation. Two sets of curves are shown, for the value $\sigma_R = 1$ GPa used above and for $\sigma_R = 0$. In this material, the enhancement of shear displacements by the residual tensile stresses is ultimately dwarfed by the influence of the frictional degradation. The trend to rapid degradation as n

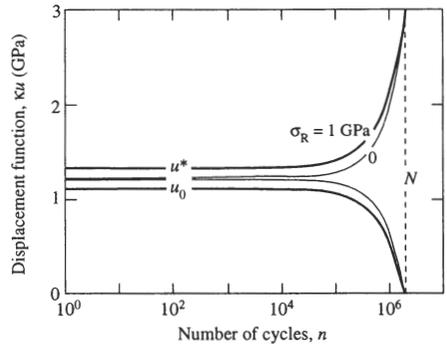
Fig. 9. Plot of displacements u_0 and u^* [equation 5(a) and 5(b)] as function of number of cycles for silicon carbide composite. Calculation assumes linear fall-off in friction (equation 6), to zero at $N = 2 \times 10^6$ (total degradation state). Computed for two internal residual stresses σ_R . Note rapid increase in displacements after $n \sim 10^5$ cycles [cf. Fig. 2(F)].
